POL PIER REPAIRS
LAJES FIELD, AZORES

CONSTRUCTION INSPECTION VISIT NO. 3
SEPTEMBER 25 TO OCTOBER 3, 1980

CONTRACT NO. N-62477-79-C-0021
MODIFICATION P-00001

THE DEPARTMENT OF THE NAVY
NAVAL FACILITIES ENGINEERING COMMAND
CHESAPEAKE DIVISION
WASHINGTON, D. C.

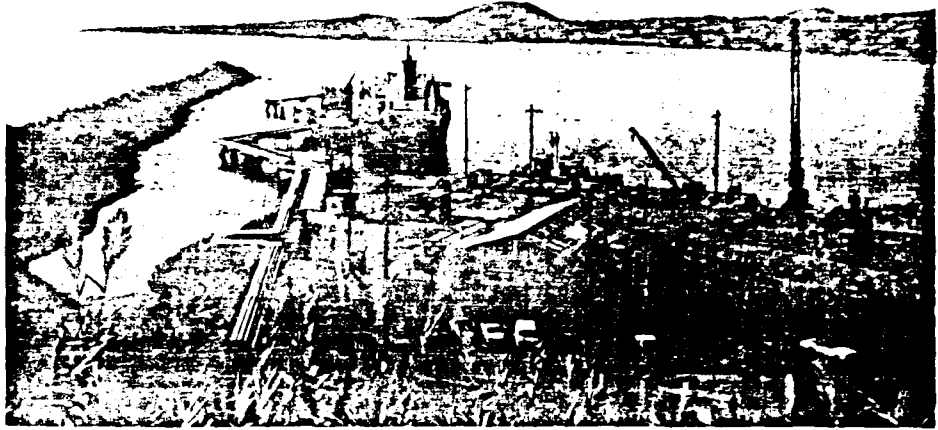
POL PIER - OVERALL VIEW
First Ship to Be Berthed - "World Promise" - After
the 100-Day Shutdown Period. Unloaded 41,000 BBL
of Diesel Oil

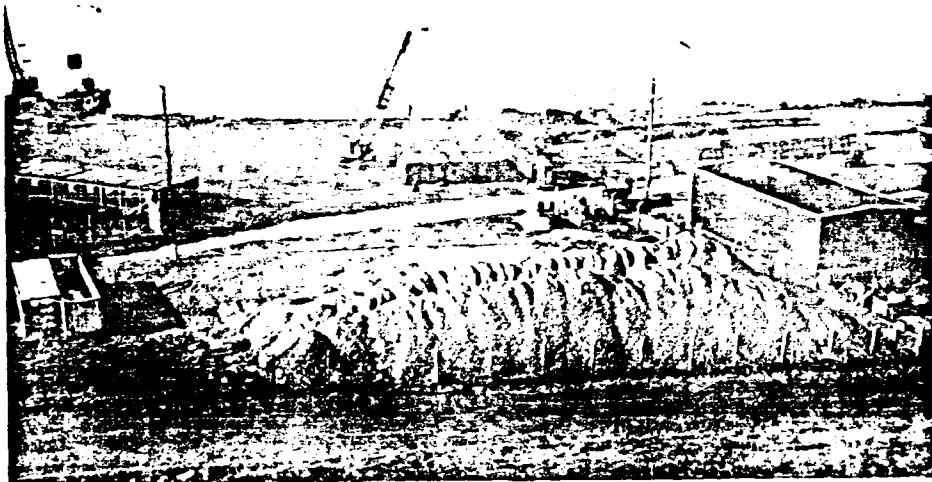
SHORESIDE - OVERALL VIEW

Crushed Stone Stockpiled to Be Used to Fill Both the New North and South Dolphins. Adjacent DANAC Workshop to Be Dismantled Upon Completion of Construction.

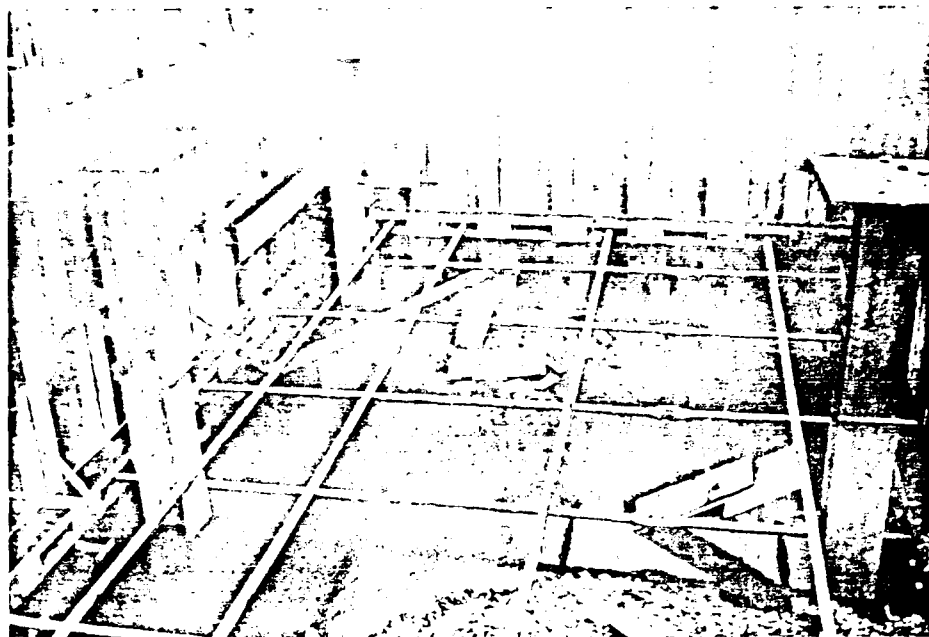
NEW NORTH DOLPHIN
Looking North at the Internal Water and Tie Rod System. The Cell is Partially Filled with Crushed Stone

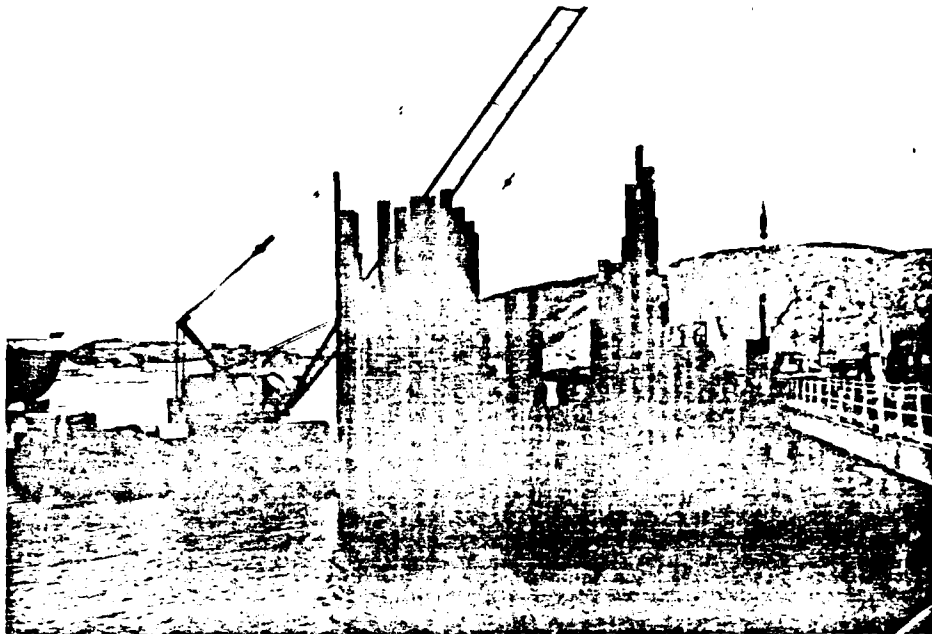
NEW SOUTH DOLPHIN

Overall View, Looking North. The North, East and South Walls Are Partially Driven. The South End of the East Wall Is "Hung Up" on an Obstruction About 5 Feet Below the Harbor Bottom.

at an angle. However, questioning could not confirm who had identified the obstruction, or the certainty that it was a pile. Nevertheless, dives have been made and since the upper sand in the harbor bottom is very loose, the divers were able to dig under the steel sheets and feel the tip end of the obstruction. During the visit, there were discussions about removing the obstruction, jetting, etc., but nothing was done. The Contractor attempted to organize divers, obtain firehose for jetting, but this did not materialize. There were equipment breakdowns, etc. and coordination problems which prevented work. It is understood that this hung up sheeting has existed since mid-September. Nothing was done to correct it, since the 100-Day Pier Shutdown Period was coming to a close and the Contractor believed they would not be able to operate because of the scheduled ship berthings. However, the berthings did not materialize and, in hindsight, it would have been possible to remove the obstruction and continue with driving the east wall of the cell.

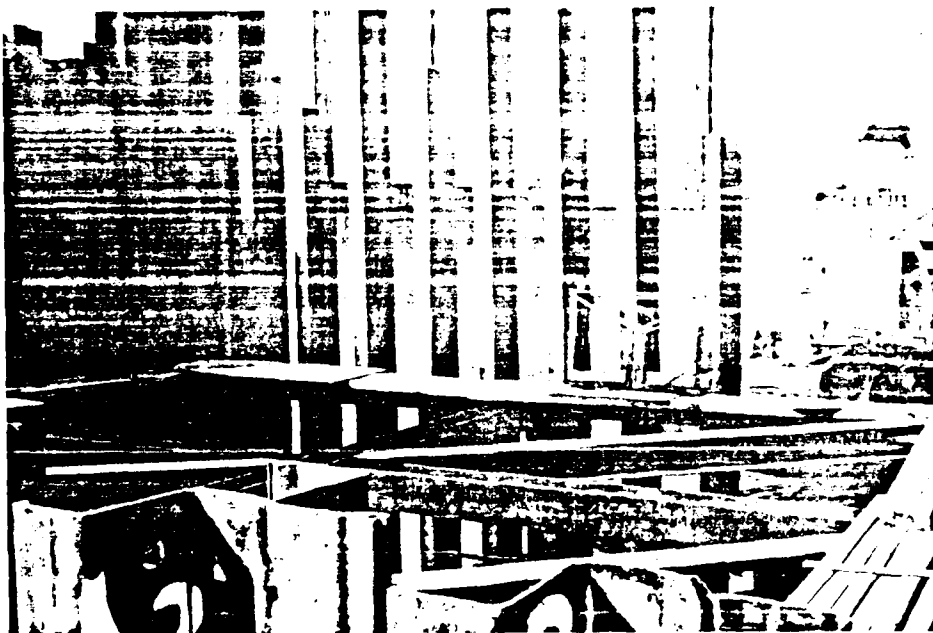
NEW SOUTH DOLPHIN

Looking West at Threading of the West Wall. The Soldier Beam Sheet Piles Are Placed First, Later, the Intervening Sheets Will Be Threaded.

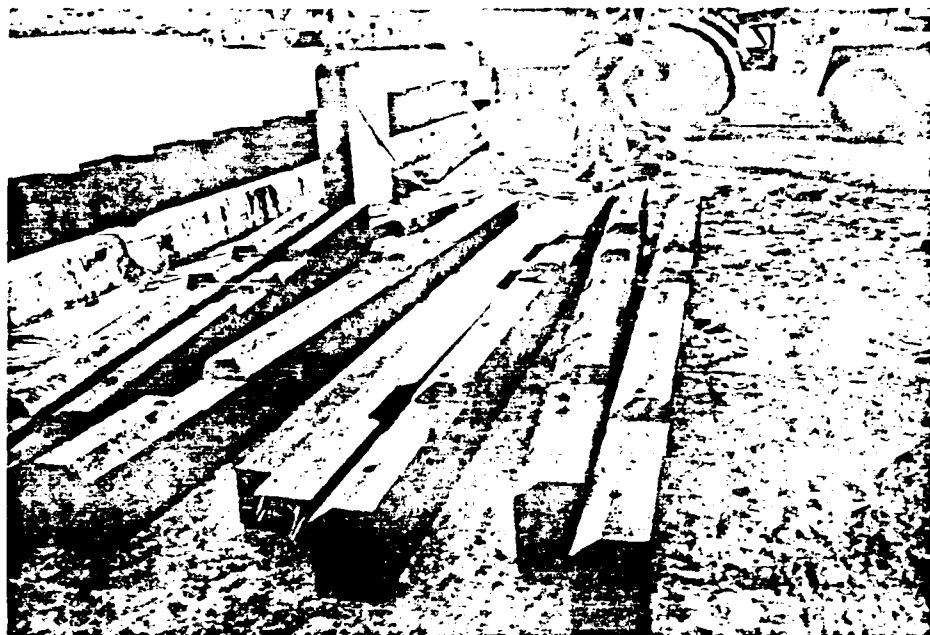
TIMBER FENDER FILLERS - LOADING PLATFORM

Timber Fillers Are Cut to Fit Around the Extended Bolts of the Steel Walers. The Cut Recesses Will Be Painted with a Wood Preservative.

During the visit, the Contractor started burning holes in the sheeting for installation of the timber fillers, to be located inside the flutes of the sheeting, so as to form a smooth bearing wall for the Sea Cushion fender units, as they ride up and down with the tide. The Contractor's attention was specifically called to the need to place preservative on the cut timber and this was later done.

The Contractor was alerted not to burn holes in the sheet piles any larger than necessary to fit the bolt.

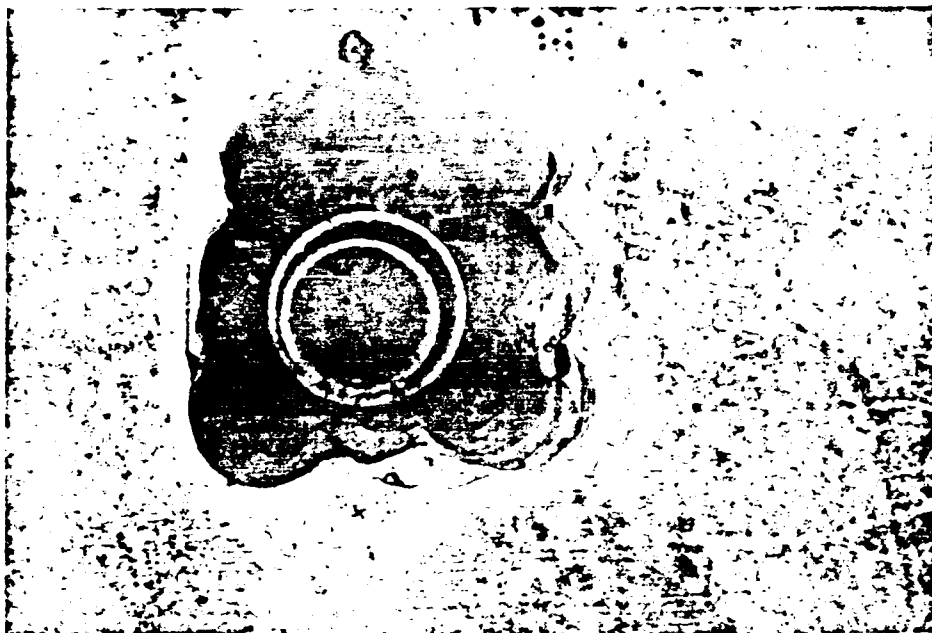
ROCK ANCHORAGE

Dolphin No. 3 - Center Anchorage with 8 Inch Casing Telescoped Inside the 10 Inch Casing. Note Smooth Drilled Concrete Cap Opening Which Will Have to Be Undercut, Roughened and Reinforced.

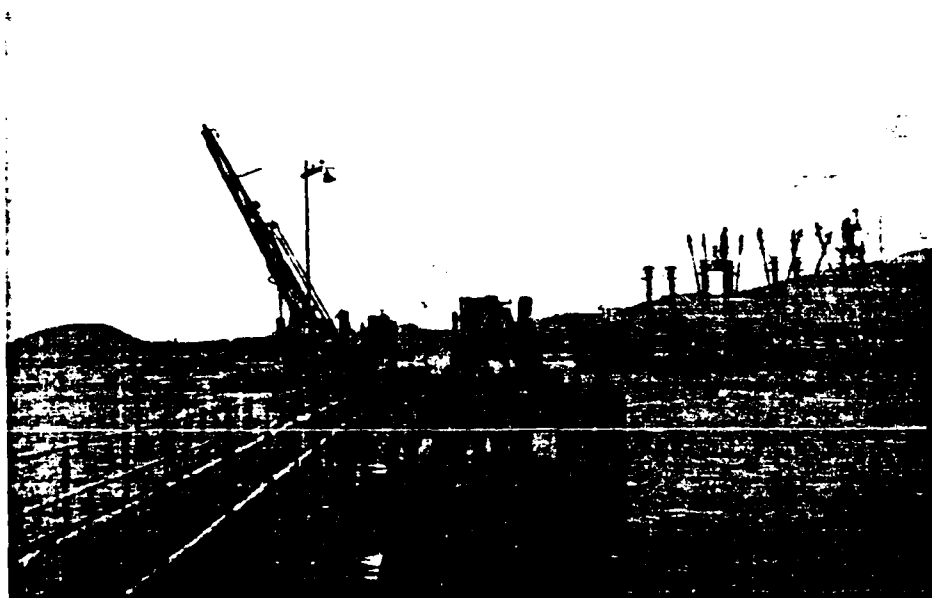
ROCK ANCHORAGES

Dolphin No. 4 - The Large Drill Rig Provides Power and Weight to Hold Down the Cantilevered Extension on Which the Small Drill Rig Sits, to Drill a Battered Rock Anchorage
